The Virginia Company

Jamestown Settlement
Forts

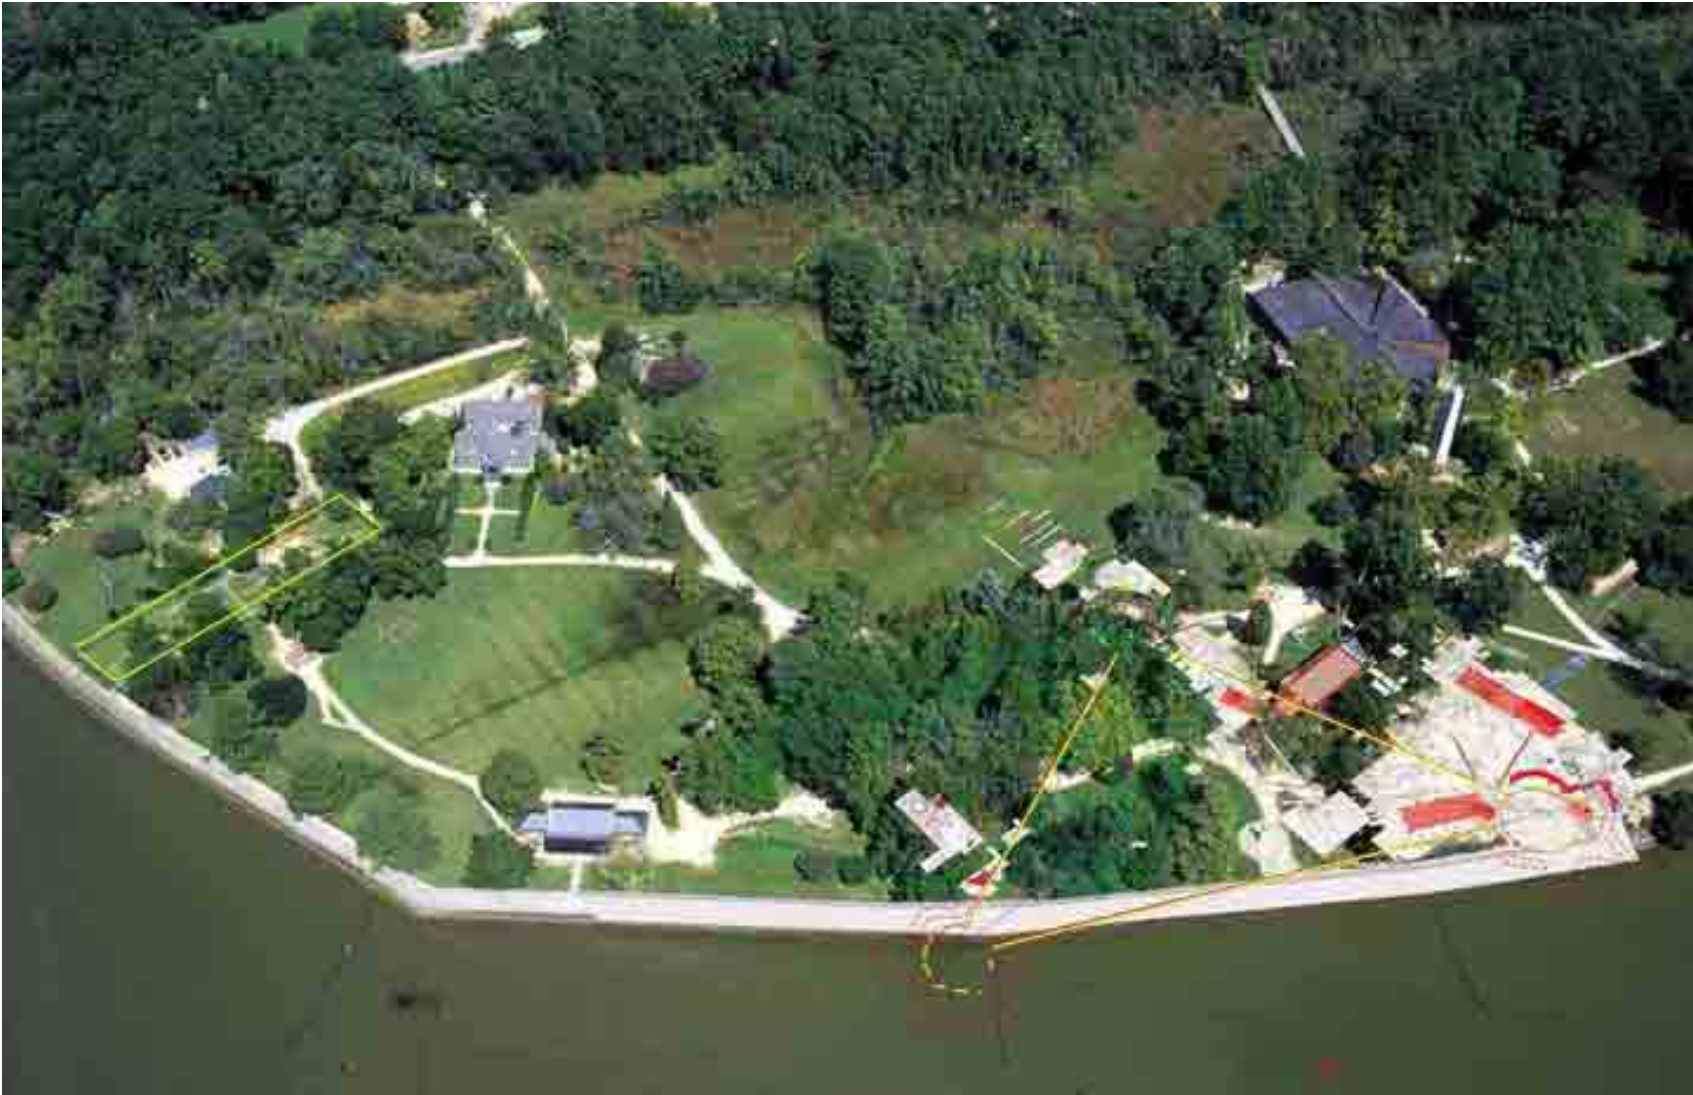
Fort James – Virginia

Excavation since 1994 has uncovered hundreds of thousands of artifacts dating to the first half of the 17th century. Nearly half of the objects date to the first years of English settlement (1607-1610). The site of James Fort was not washed into the river as most people believed for the past 200 years. We have uncovered over 250 feet of two palisade wall lines, the east cannon projection (bulwark), three filled in cellars, and a building, all part of the triangular James Fort.

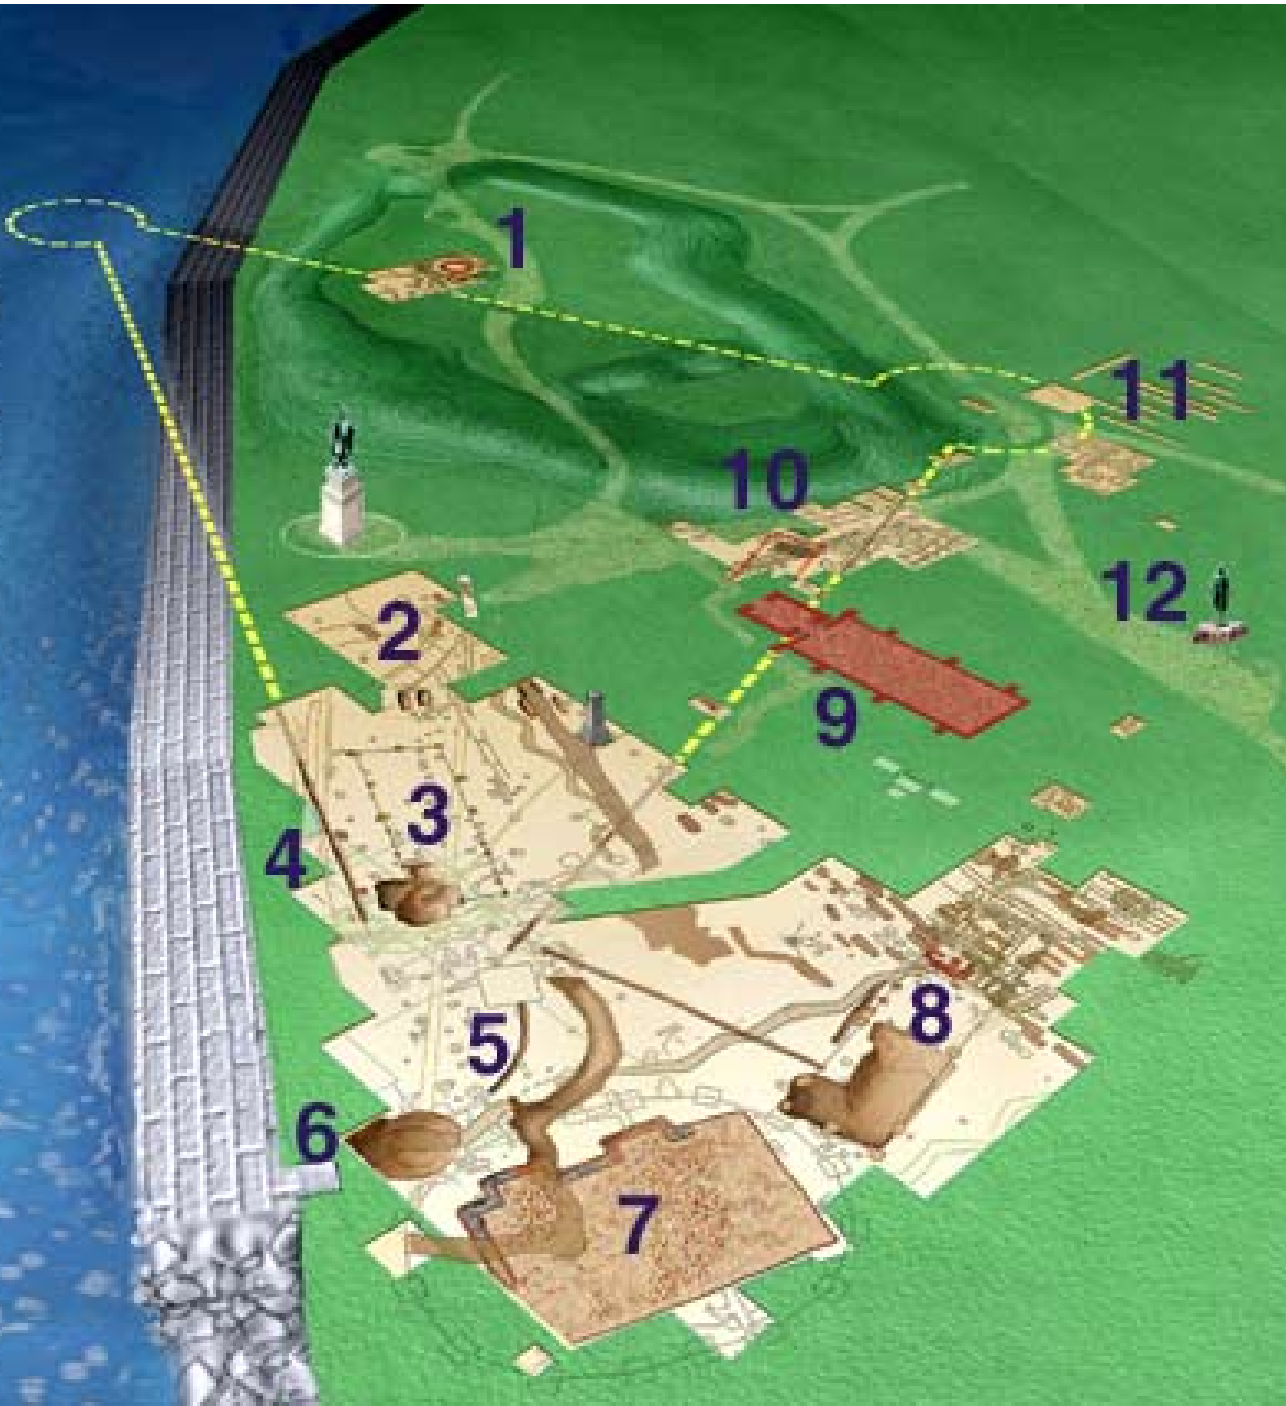
The excavation sites

- 1 = well
- 2 = Burials
- 3 = Barracks?
- 4 = S. Palisade
- 5 = E. Bulwarks
- 6 = Powder Magazine
- 7 = John White's
- 8 = "out" building
- 9 = Church
- 10 = N. Church
- 11 = N. Bulwark
- 12 = Pocahontas Statue

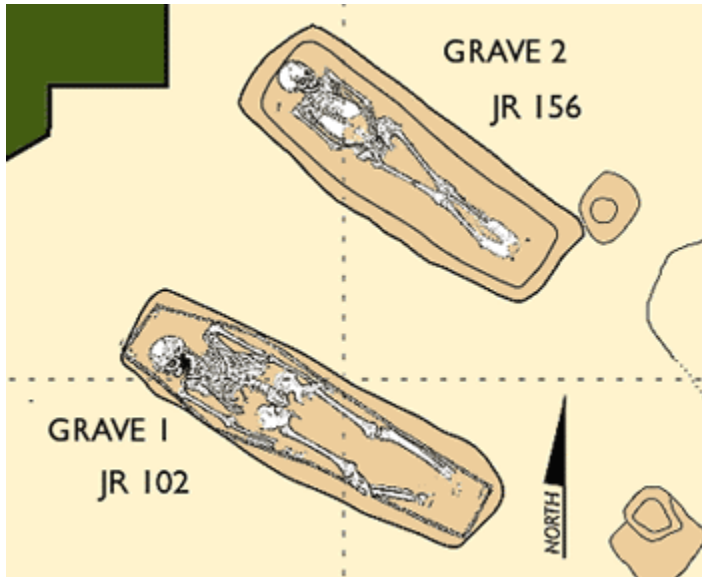
Drawing showing the proximity of the two burials excavated by *Jamestown Rediscovery*.

[Burial 1](#) -- JR 102C A young man with a bullet shattered leg.

[Burial 2](#) -- JR 156C An older woman with surviving coffin wood.

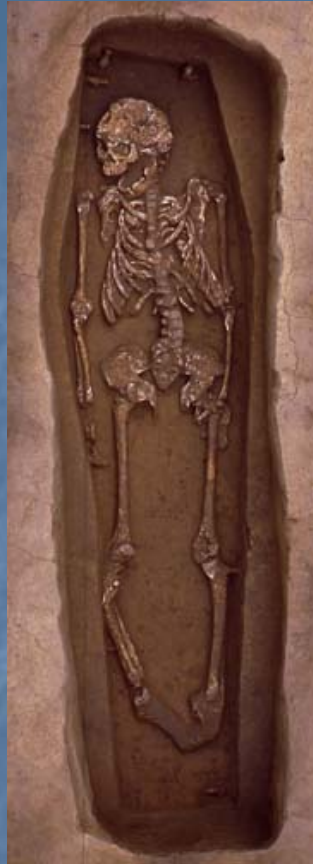
The skeleton was that of a white male, only 18-20 years of age. He was about 5'9" and slightly built, but with a fairly strong upper body. His teeth and bones show no signs of early childhood diseases. His right leg is broken and twisted below the knee, where the young man was shot. [A lead musket ball and smaller lead shot](#) remain on and within the bone. This wound, and the resulting loss of blood was the likely cause of death. There appears to have been no attempt to remove the lead, or to set the leg, and no healing took place in the bone prior to death. There is no evidence indicating additional wounds to the body.

The young man was buried in a six-sided, flat lidded coffin, which was shown by soil stains from the decayed wood, and by the rusted iron nails used to build it. The fact that he was buried in a coffin may suggest that he had a gentleman's status.

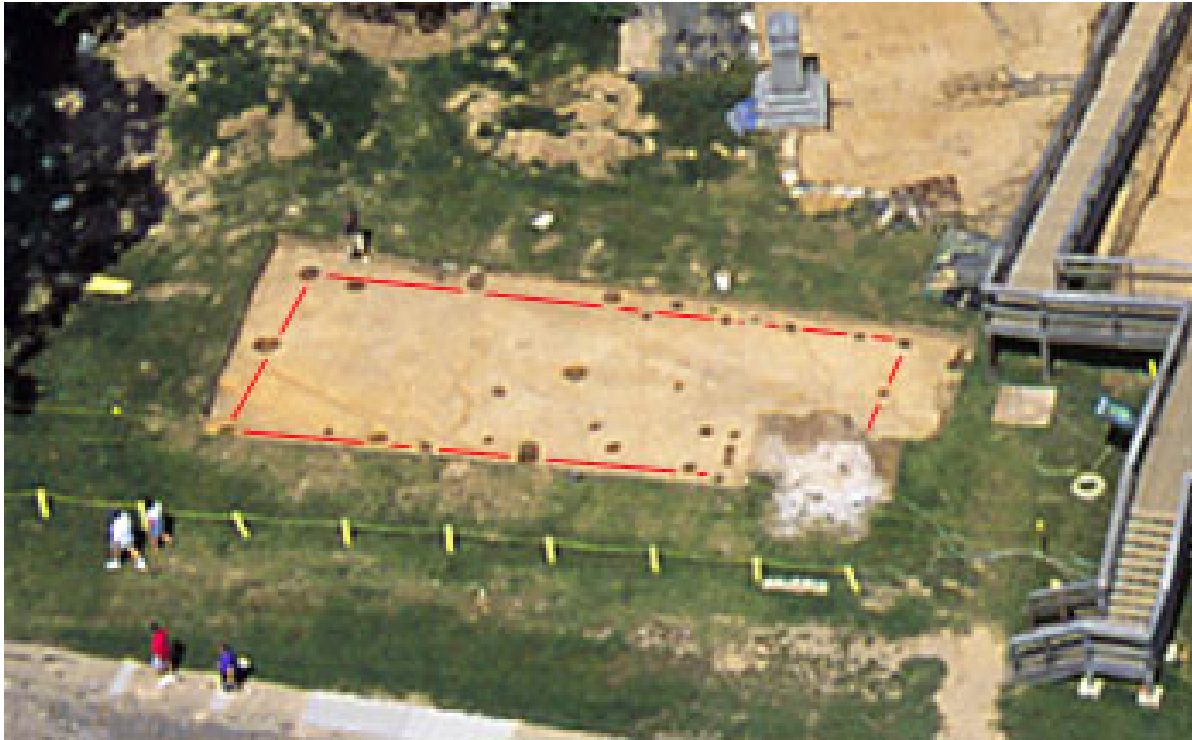
3. Barracks

...Structure 160, helped identify the likely parent tradition of this type of architecture. Known as “Mud and Stud” this style of building was used in and around the East Lindsay region in the county of Lincolnshire along England’s East Coast....The pairing of the earthen walls and the wooden internal frame creates a solid wall on which to support the roofing timbers and thatch. There are existing 16th century examples of such structures still standing in Lincolnshire complete with the clay chimneys.

Documentary accounts from the early years at the fort describe the buildings in similar terms. John Smith description of the 1607 church as “set upon cratchets, covered with rafts, sedge, and earth.... While three years later William Strachey described the houses as “at first pargeted and plastered with bitumen. Both the reference to earth as well as bitumen indicate mud walled structures and Strachey’s use of the term pargeted indicates a white washed exterior, both typical of mud and stud construction.

After the building went down or at least part of it, the cellar expanded apparently to acquire clay material for plastering (daubing) the walls of a building. These pits were probably used for mixing the daub as well, with the central shaft supplying ground water. In the central shaft we found the impressions of [marsh grasses](#) that would have been used to mix with the clay as a binder. The most spectacular thing about the cellar/pit was the large number of artifacts found in the soil used to back fill it.. Over 44,000 objects were found in the sealed contexts of the pit. This material is the oldest extensive collection of English artifacts found in America. A complete [Cabasset helmet](#) (the first helmet found at Jamestown and only the fifth in Virginia) was found in the bottom of one of the sub pits. A large proportion of the artifacts found was military or industrial in nature.

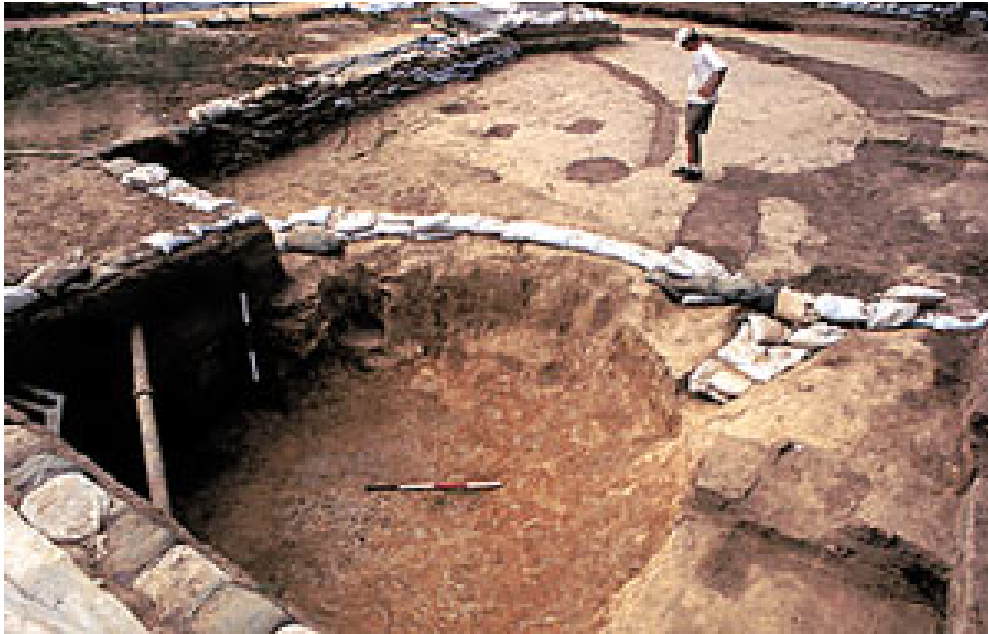
6. Powder Magazine

The artifacts found here indicate a fill date sometime in the early James Fort period. Broken [ceramic vessels](#), military hardware, tobacco pipes, coins, [tokens](#), and a [medical implement](#), all dating around 1610 were found in the sealed contexts of the pit. How this feature relates to the bulwark and the chronology of the fort construction overall is still being researched. However, it is possible that it served as a place to store powder near the bulwark guns but deep enough to prohibit accidental explosions.

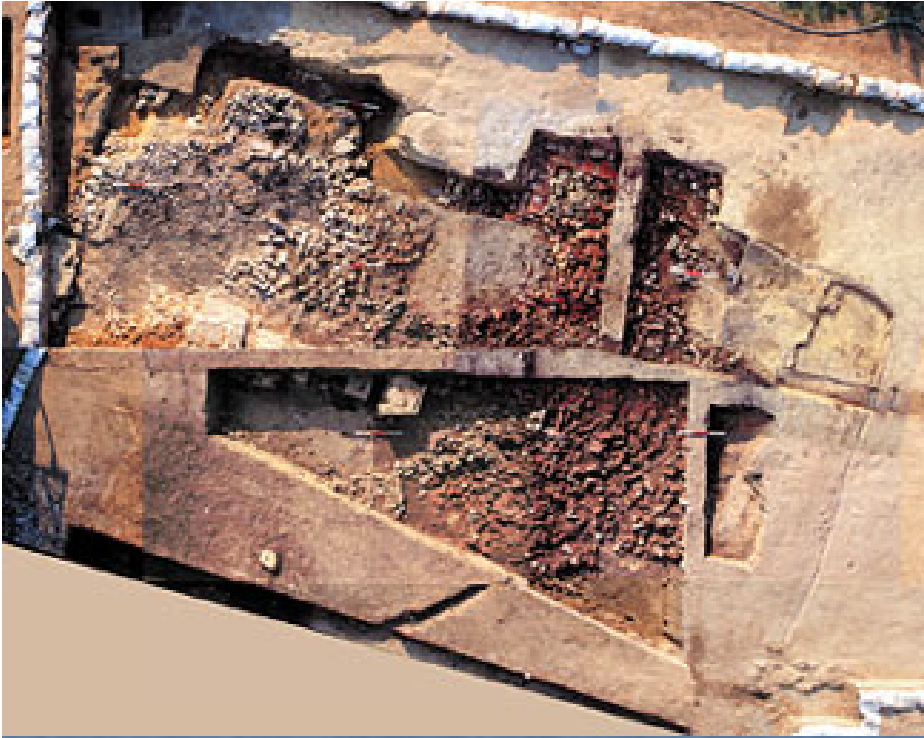
7. John White's

The middle of the 1620's saw James Fort decline in importance as Jamestown came into it's own as the capitol of the Virginia colony. The [change from military outpost to a more stable community](#) is reflected in the archaeological record, especially the architecture. Throughout the second quarter of the 17th century the use of more permanent building materials became more common as the town grew out of the fort. Brick makers had come to Virginia as early as 1608 but it wasn't until the 1620's that brick was used extensively in the construction of buildings.

The site of John White's House and/or Warehouse was located just east of James Fort. It represents the transition from the wood and mud barracks type buildings of James Fort to the brick structures that sprang up around the "New Town" to the east after the Fort ceased to exist. It is a large structure by 17th-century standards, 46 x 30 feet. The foundations, which are only partially excavated to date, are built of brick and stone.

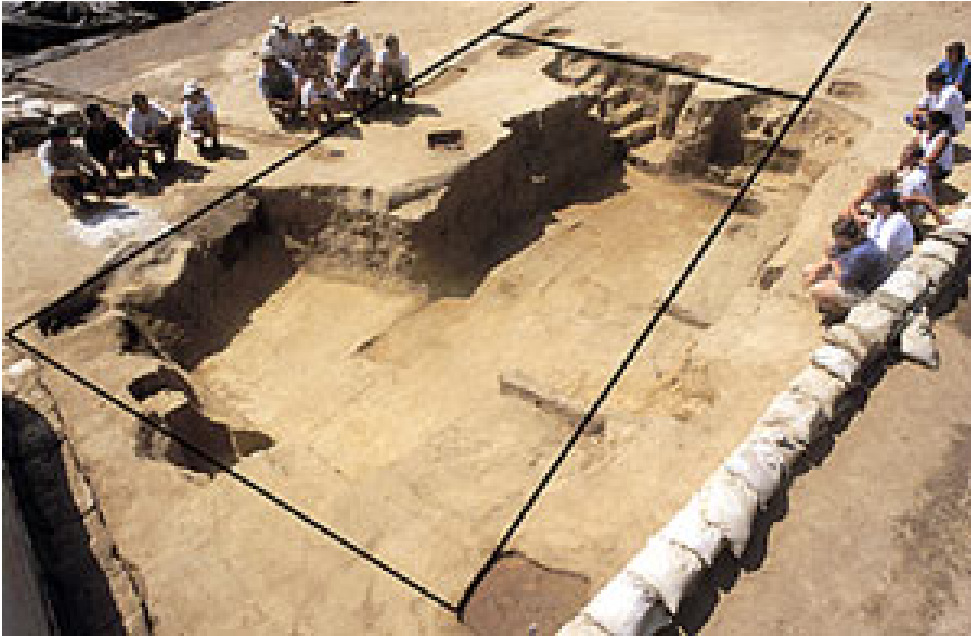
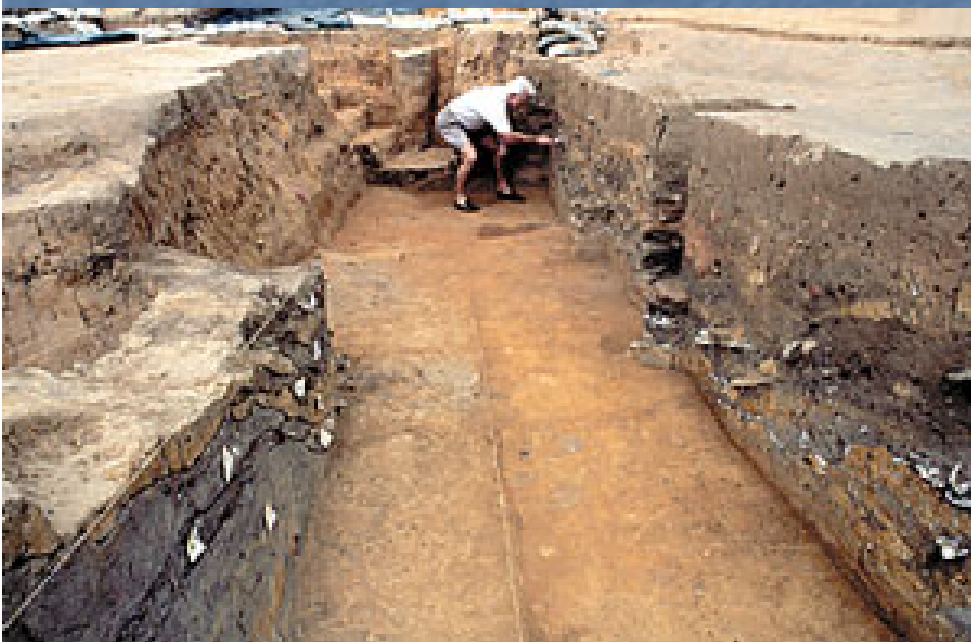
8. Out Building

Excavations of an early extension to the core James Fort revealed an L-shaped hole located at the end of a 50 foot palisade wall trench extending east of the triangular Fort. Complete excavation of the feature discovered that the hole was actually a cellar built in two stages under a building supported by up-right posts in the ground. The cellar has steps descending from one corner, had once been partially walled with timber, had a fire place area, and two barrels buried in and below the floor to drain it. This could have been used as a jail or even the dungeon where John Smith once held a Powhatan Indian captive.

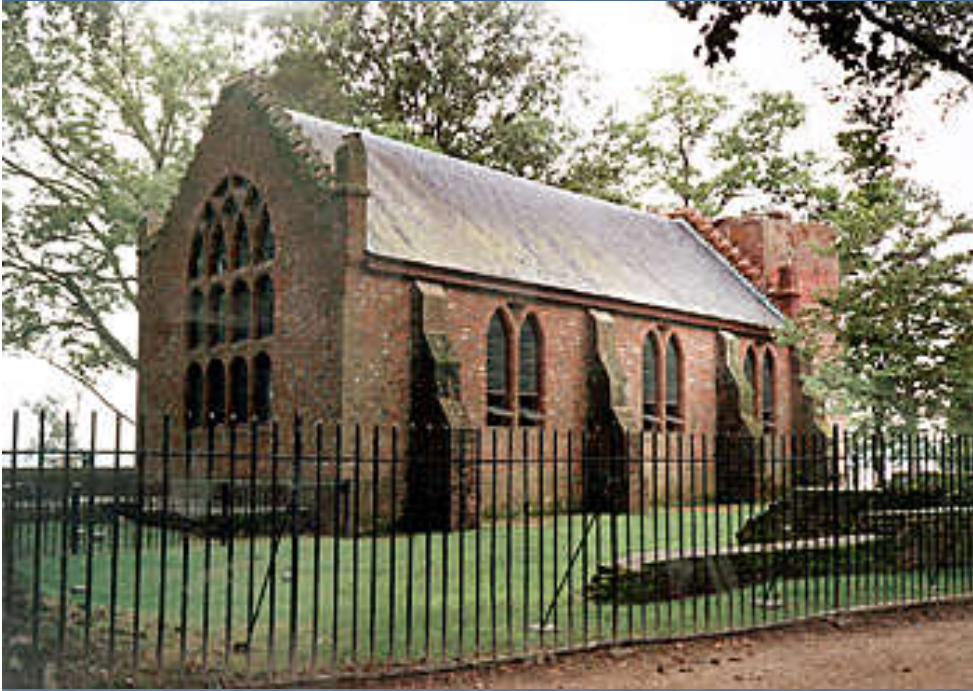
9. The Church

The First and Second Churches--Captain John Smith reported that the first church services were held outdoors "under an awning (which was an old saile)" fastened to three or four trees. Shortly thereafter the settlers built the first church inside the fort. Smith said it was "a homely thing like a barn set on crachetts, covered with rafts, sedge and earth." This church burned in January, 1608....

The Third Church--In 1617-1619... was a wooden church built on a foundation of cobblestones one foot wide capped by a wall one brick thick. You can see these foundations under the glass on the floor of the present building. The First Assembly was held in the third church.

The Fourth Church--In January, 1639... was slightly larger than the third church and was built around it. It was still unfinished in November, 1647 when efforts were made to complete it. After it was finished the church tower was added. The tower is the only seventeenth-century building still standing at Jamestown. It is one of the oldest English-built structures in the United States....

The Present Church--The present Memorial Church building was constructed in 1906 by the National Society, Colonial Dames of America just outside the foundations of the earlier churches. It was dedicated May 13, 1907.
